CUSTOM BUILDERS RESTORATION

Contract

Extent of work: Graining, re-pointing, limestone replacement, Chimney rebuilding.

Extent of work: Flashing installation, re-pointing, parapet wall rebuilding.

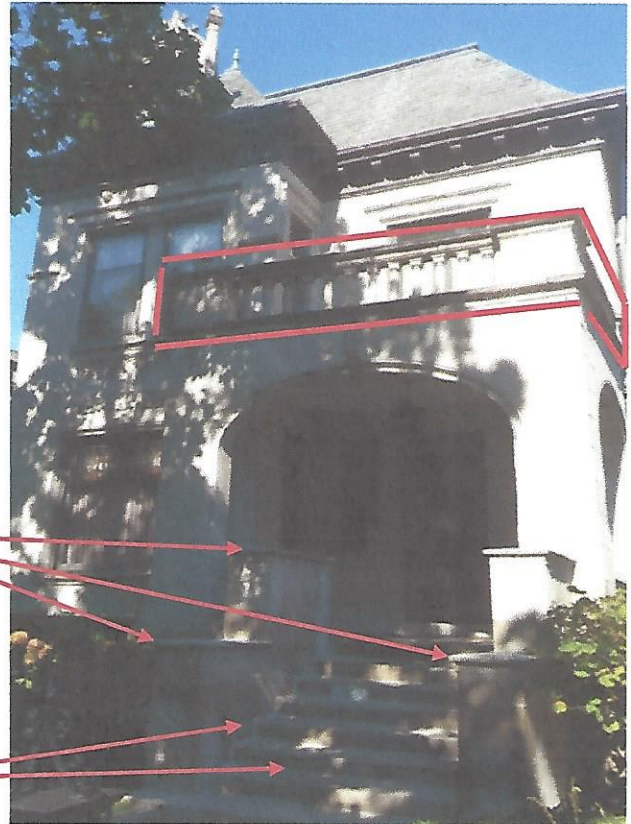
1. All mortar joints on the South side of the building, limestone elevation will be cut out (3/4 of inch deep) and re-pointed (with type O mortar. All damaged pieces of limestone will be replaced (4 peaces)
2. The top part of the porch marked on the image will be rebuild, using original limestone.
3. The copings from the stairwell (3 peaces) will be removed, new Drip edge flashing will be installed and the copings will be reset to the original position.
4. New sealant joint will be applied on the stairs joints.

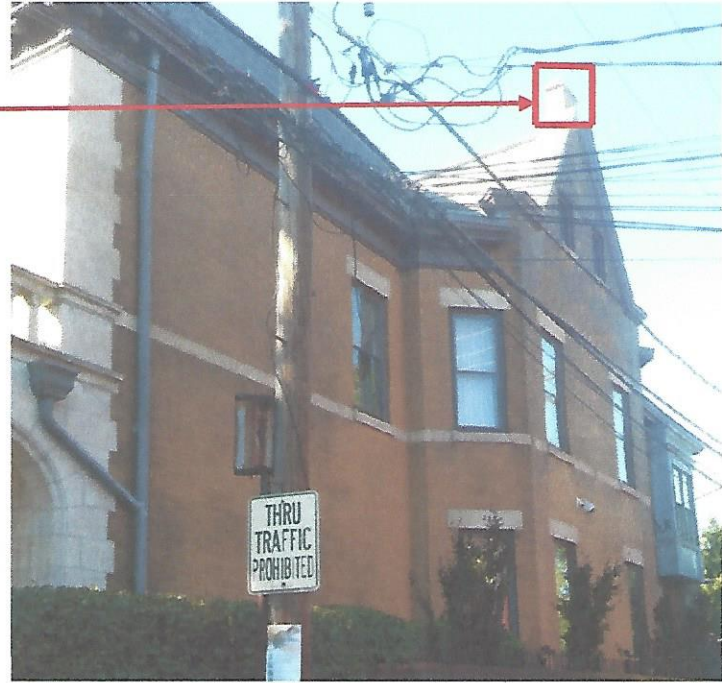
5. Rebuild the chimney on the East elevation using new face bricks to match the existing bricks on the wall as much as possible.
6. Spot re-point the East elevation (cracks, open joints as necessary).

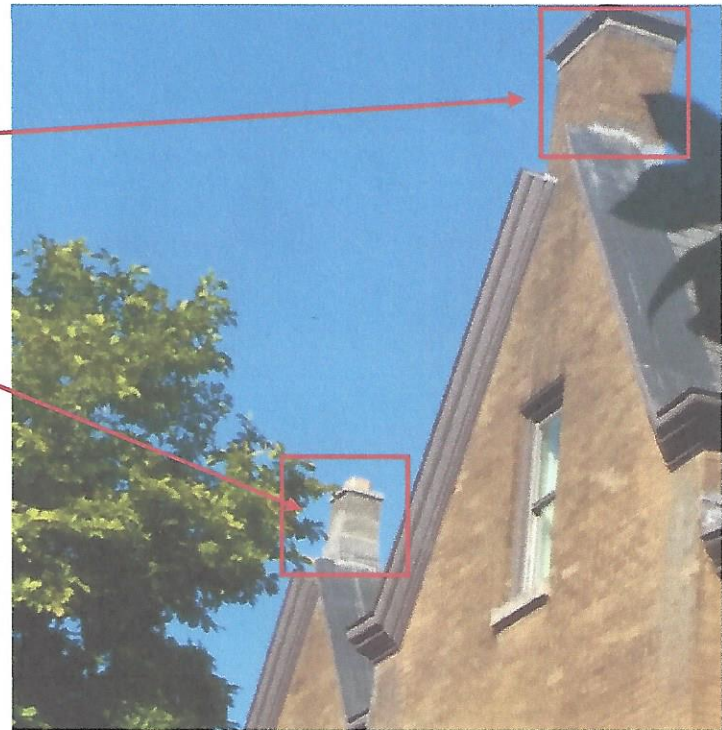
7. Grind and re-point the face brick chimney on the West elevation.
8. Rebuild the chimney on the West elevation using new face bricks to match the existing bricks on the wall as much as possible.
9. Spot re-point the west elevation (cracks, open joints as necessary).

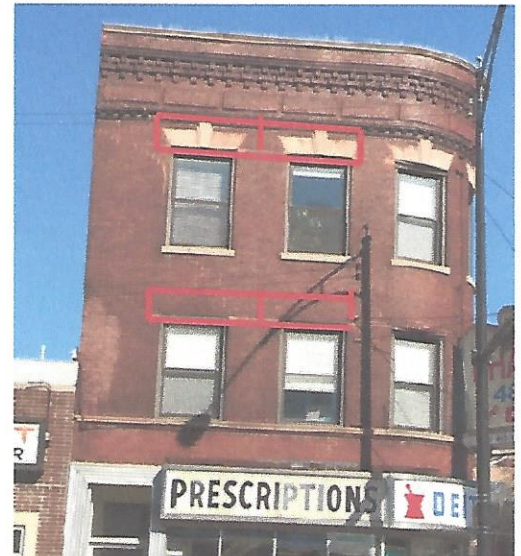
South Elevation

1. We will open the masonry above the window marked on the image as much as necessary to replace the lintels. The new lintels will be coated with epoxy paint. The drip edge, Perm-A-Barrier flashing (complete with end dams), the weep ropes every 16" and termination bar (to the backup of the wall), will be installed on the new lintels. The opening will be rebuilt with the original units. The original design of the exterior wall will be recreated with mortar color and joint type to match the existing as closely as possible. We will re-point area above the window if necessary.

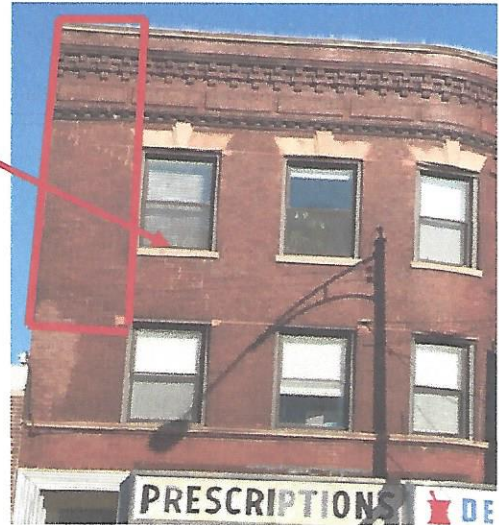
2. We will re-point and replace damaged bricks in the area marked on the image. The cracked window sill will be removed, glued with epoxy and reset back.

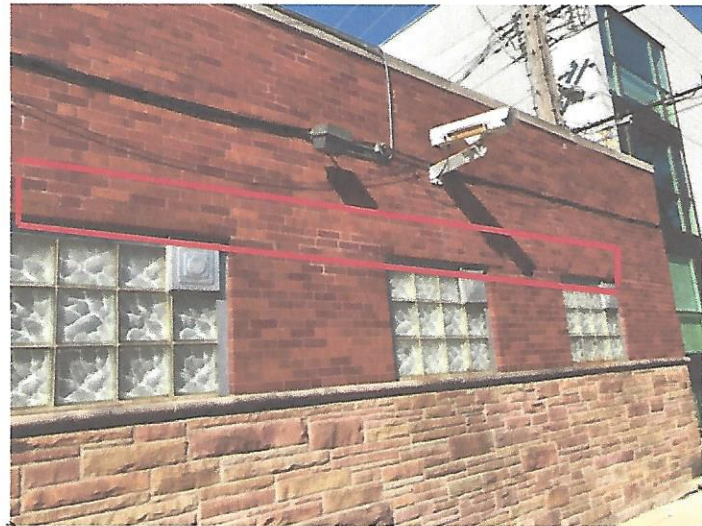
East Elevation

3. We will open the masonry above the windows marked on the image as much as necessary to replace the lintels. The new lintels will be coated with epoxy paint. The drip edge, Perm-A-Barrier flashing (complete with end dams), the weep ropes every 16" and termination bar (to the backup of the wall), will be installed on the new lintels. The opening will be rebuilt with the original units. The original design of the exterior wall will be recreated with mortar color and joint type to match the existing as closely as possible. We will re-point area above the window if necessary.

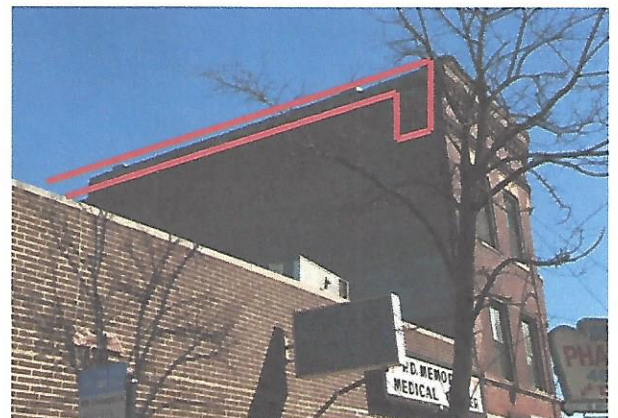
West elevation

4. The parapet wall (97' feet long) on the west elevation will be rebuilt exterior course two feet down from the top of the copings and one foot from the roof side using new face brick to match the original bricks as closely as possible. All copings will be reset on the parapet wall (the damaged units will be replaced). New roof flashing will be recreated.

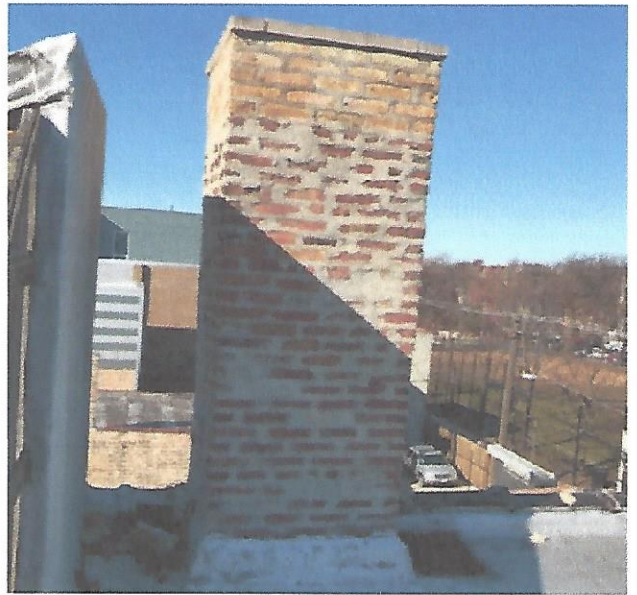
1. The chimney shown on the image will be rebuilt to the roof level, the flue liners will be replaced if necessary and the new concrete cap will be installed on the top of the chimney.
